# Job Completion Report

**Report Number JCRSAMPLE**  
**Monday 01<sup>st</sup> January 2015**

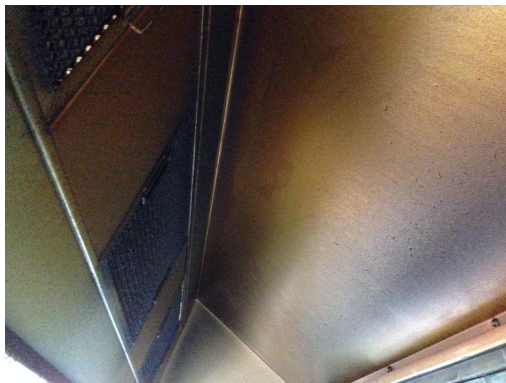
- Canopy – Heavy Levels of Grease Accumulation
- Collection Gutter – Heavy Levels of Grease Accumulation

**Image 1 – Kitchen Exhaust Canopy  
Before Cleaning Works**

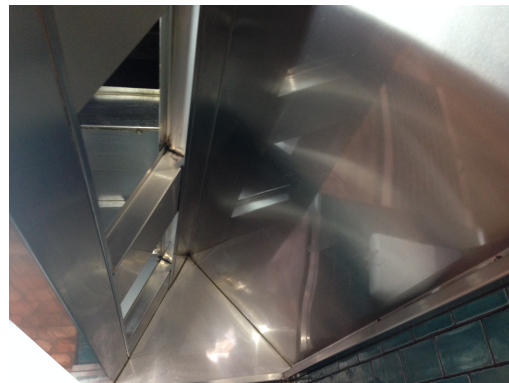
**Image 2 – Kitchen Exhaust Canopy  
After Cleaning Works**

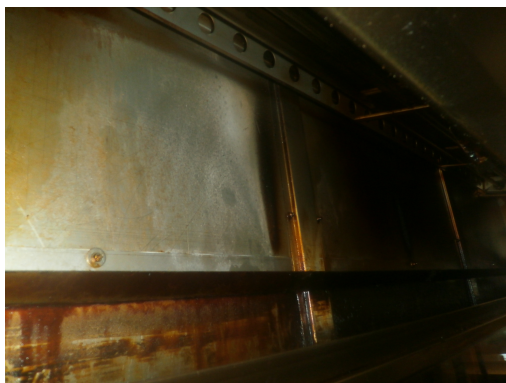
**Image 3 – Kitchen Exhaust Canopy  
Before Cleaning Works**

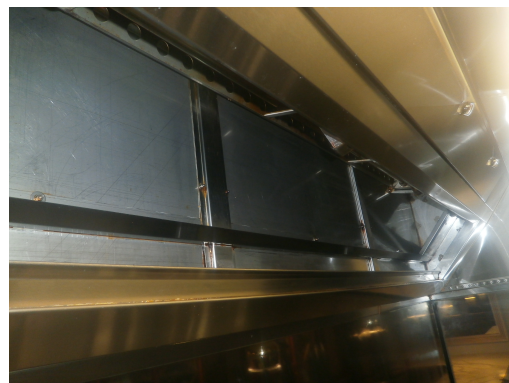
**Image 4 – Kitchen Exhaust Canopy  
After Cleaning Works**

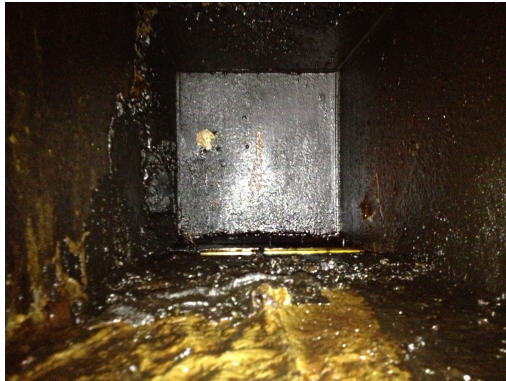
- Ductwork – Heavy Levels of Grease Accumulation
- Exhaust Fan – Heavy Levels of Grease Accumulation
- Fan Shroud – Heavy Levels of Grease Accumulation

**Image 5 – Ductwork Before Cleaning Works**

- **The Kitchen Exhaust Systems should be accessed and thoroughly inspected at minimum once every 4 months to ensure cleanliness levels are in accordance with the Australian Standard 1851 : 2012 (Maintenance of fire protection systems).**
- **The Exhaust Ductwork is harbouring extremely heavy levels of grease and foreign contaminants and is recommended by Exhaust Hygiene Services that it be accessed and cleaned to eliminate the high fire risk that is being presented by the system.**

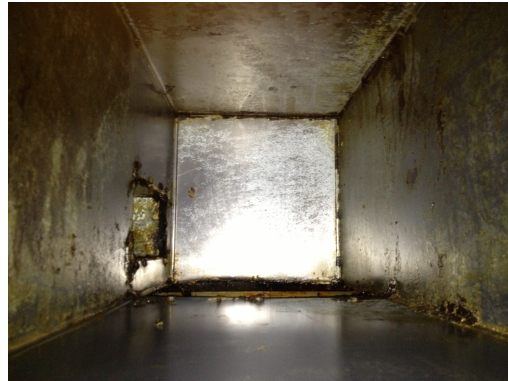
**Image 6 – Ductwork After Cleaning Works**

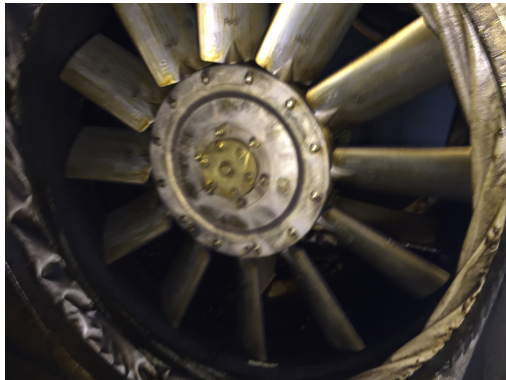
**Image 7 – Exhaust Fan Before Cleaning Works**

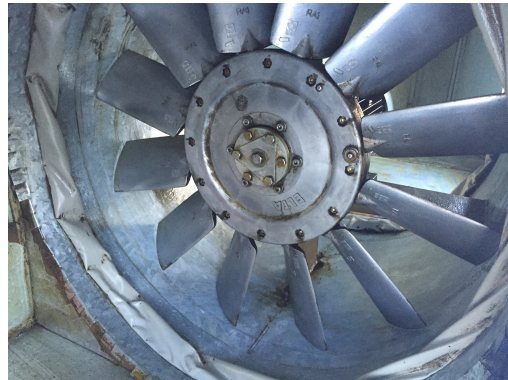
**Image 8 – Exhaust Fan After Cleaning Works**
